Manhole Inspection Summary

Manhole # S13GG1012MH

Location Address: **REAR- 4151 PARK HEIGHTS AVE** Cross Street: **QUANTICO AVE**

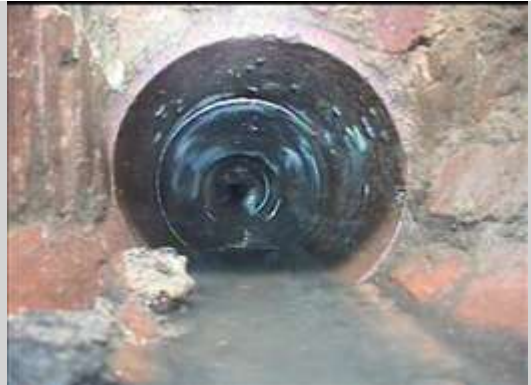
12 O'Clock Outflow

8 in. Circular Gravity Sewer
Pipe Out @ 12 O'Clock

Pipe Material: **Clay** ☐ Pipe Lined

Invert Depth: **6.15** (ft.) Flow Characteristics: **Slow**

Deposits: ☒ None ☐ Mud ☐ Gravy ☐ Debris ☐ Grease

Infiltration: **None** Pipe Seal Cond: **Sound**

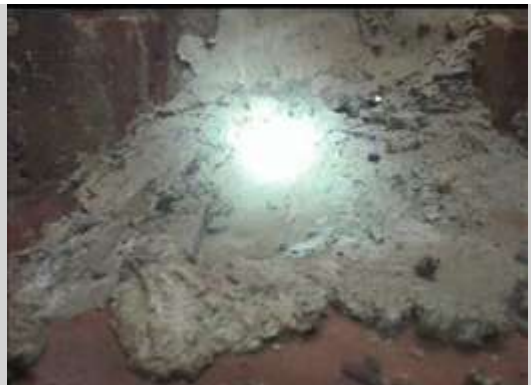
3 O'Clock Inflow

8 in. Circular Gravity Sewer
Pipe In @ 3 O'Clock

Pipe Material: **Unknown** ☐ Pipe Lined

Invert Depth: **5.71** (ft.) Flow Characteristics: **None**

Infiltration: **None** Pipe Seal Cond: **Unknown**

Connects To: **Stub connection / abandoned**

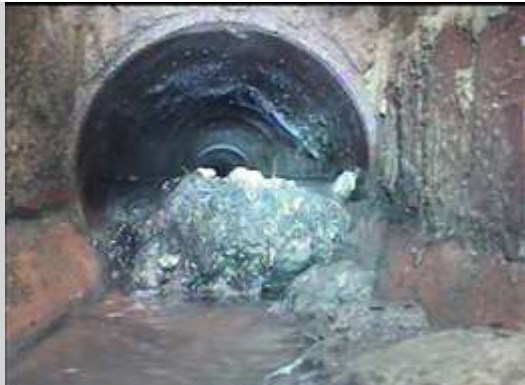
6 O'Clock Inflow

8 in. Circular Gravity Sewer

Pipe In @ 6 O'Clock

Invert Depth: **6.09** (ft.) Flow Characteristics: **Slow**

Deposits: ☐ None ☐ Mud ☒ Sludge ☒ Debris ☒ Grease

Silt Depth: **3** (in.) Deposits Extent: **Medium**

Connects To: **Dead End**

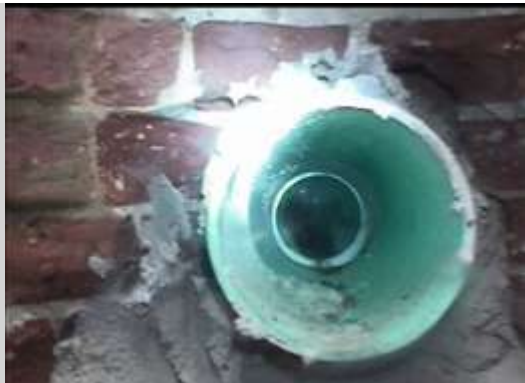
9 O'Clock Inflow

6 in. Circular Gravity Sewer

Pipe In @ 9 O'Clock

Pipe Material: **PVC** ☐ Pipe Lined

Invert Depth: **3.28** (ft.) Flow Characteristics: **Slow**

Pipe Seal Cond: **Sound**

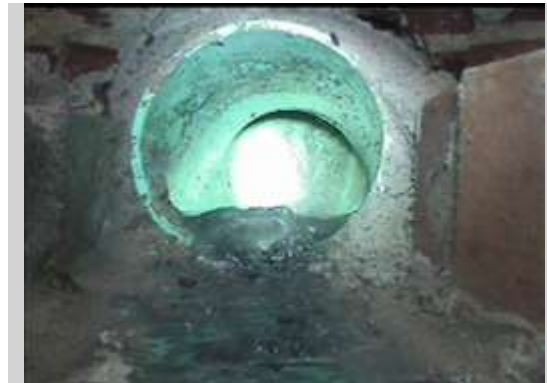
Drop In @ 9 O'Clock

Drop: **Outside Direct**

Inv Depth: **5.59** (ft.)

Drop Condition: **Open**

Connects To: **House connection / Service line**
